TECHNICAL REPORT S-71-II

**COMPARISON OF PERFORMANCE OF  
EXPERIMENTAL MEMBRANES, NONSKID  
COMPOUNDS, ADHESIVES, AND EARTH  
ANCHORS WITH REGARD TO C-130 AIRCRAFT  
OPERATIONAL REQUIREMENTS**

**T. W. Voller**

August 1971

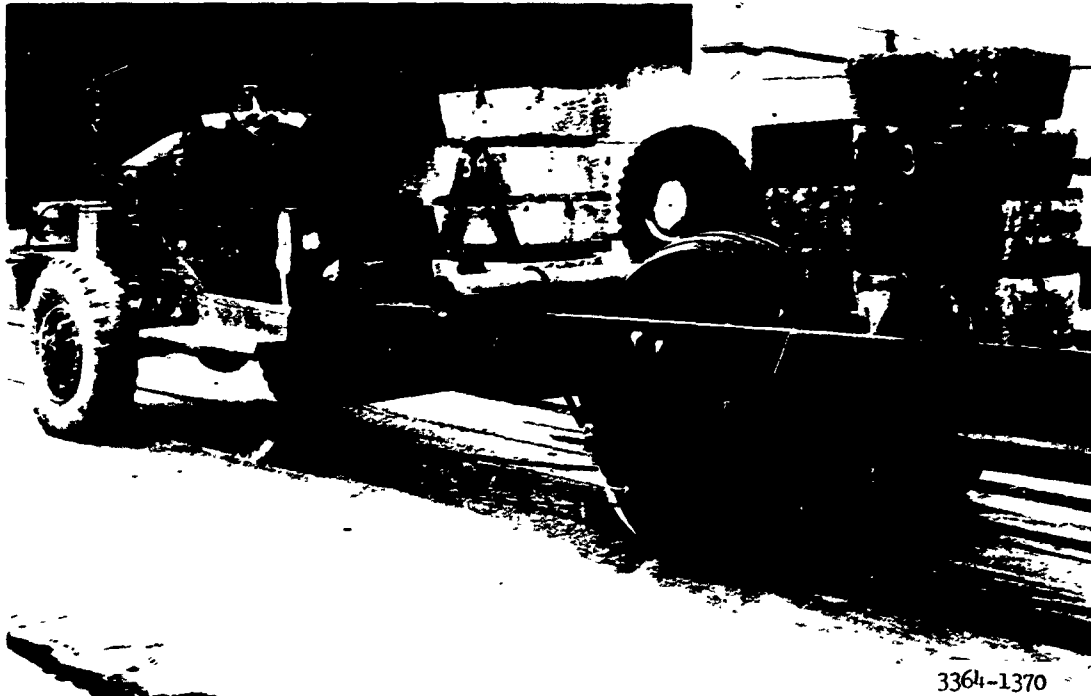
Fig. 1. Skid cart made from the front half of 6x6 Army truck with load frame attached

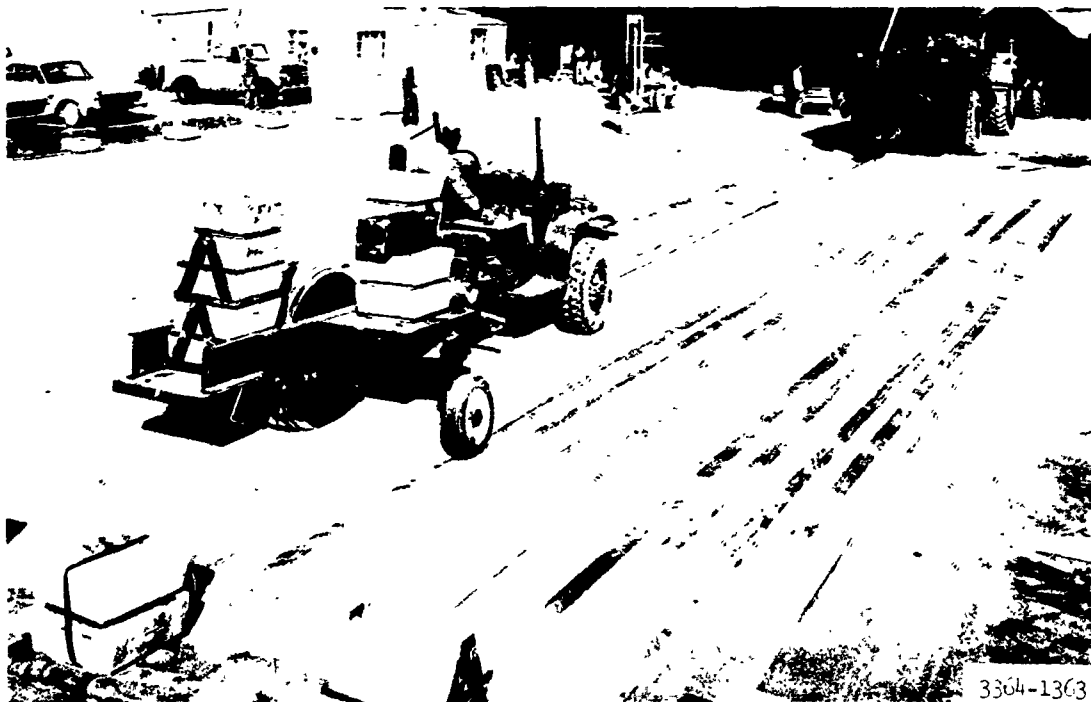
Fig. 2. Skid cart being pulled across dry membrane

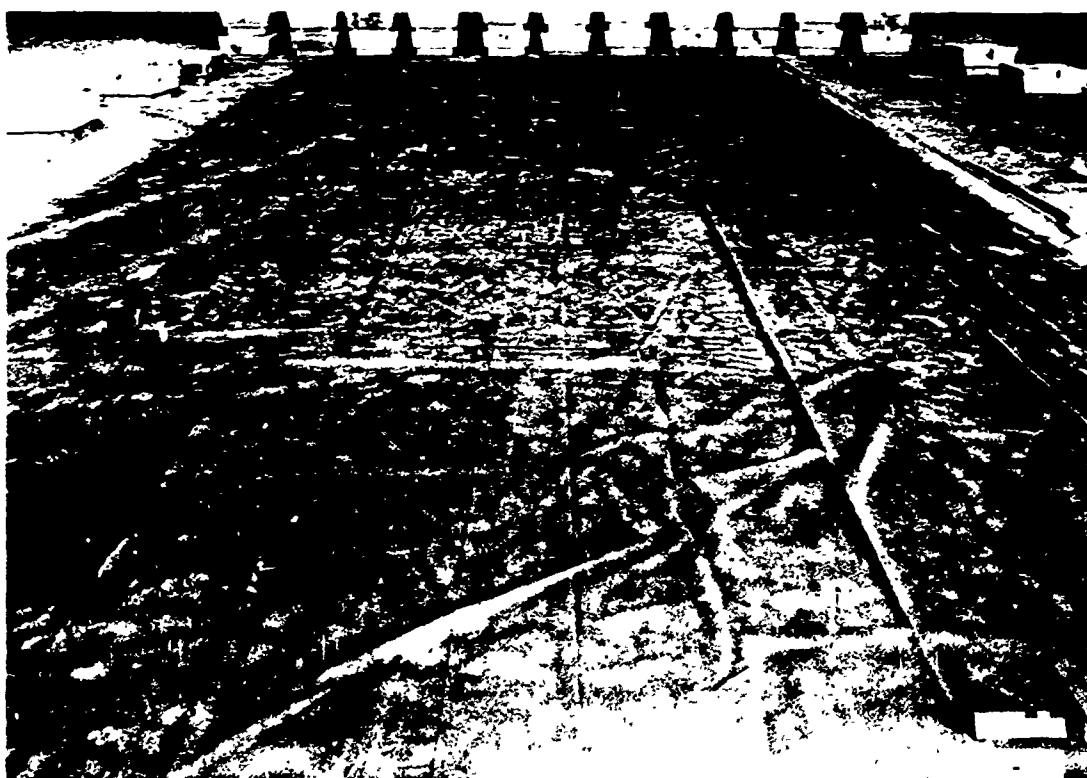
19. T17 membrane. Because a great amount of data is available at WES concerning T17 membrane, its performance was used as a standard with which the performances of the experimental membranes were compared. The section prior to testing is shown in photograph 2. The appearance of this nonskid-coated membrane is typical of that of all membranes tested. Results of the skid tests on the T17 membrane are described as follows:

Photograph 2. T17 membrane surfacing completely coated with nonskid compound prior to skid tests

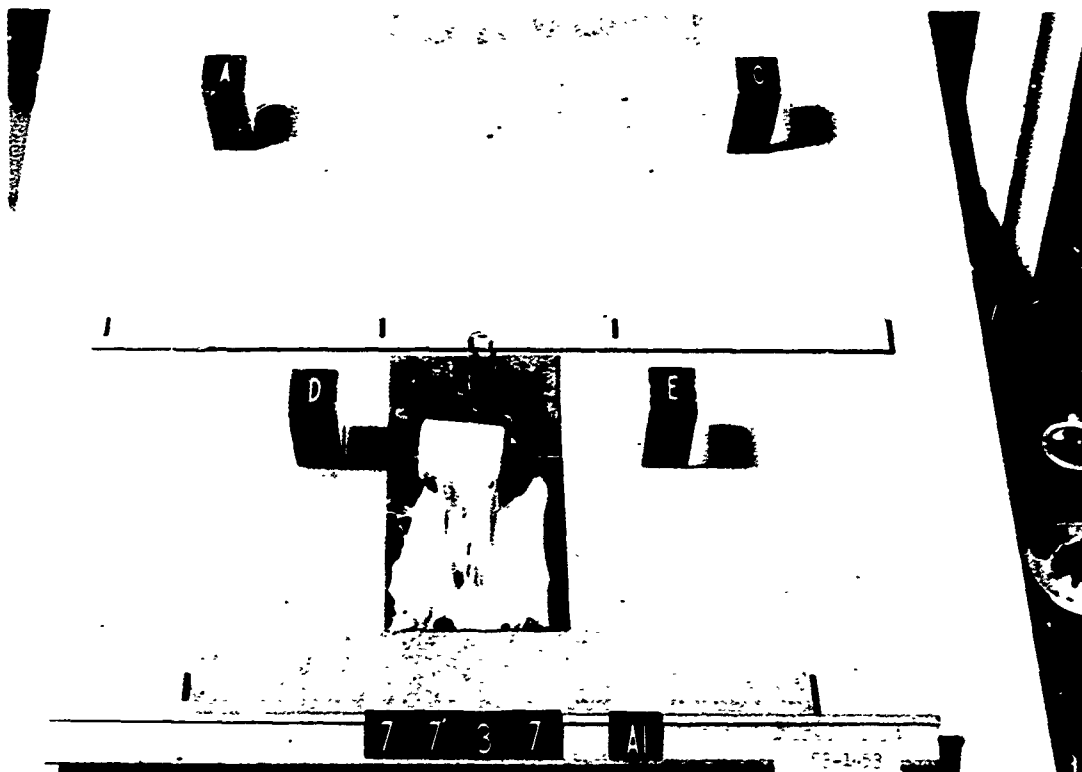
Photograph 87. Application of Z7737 adhesive after one-year storage

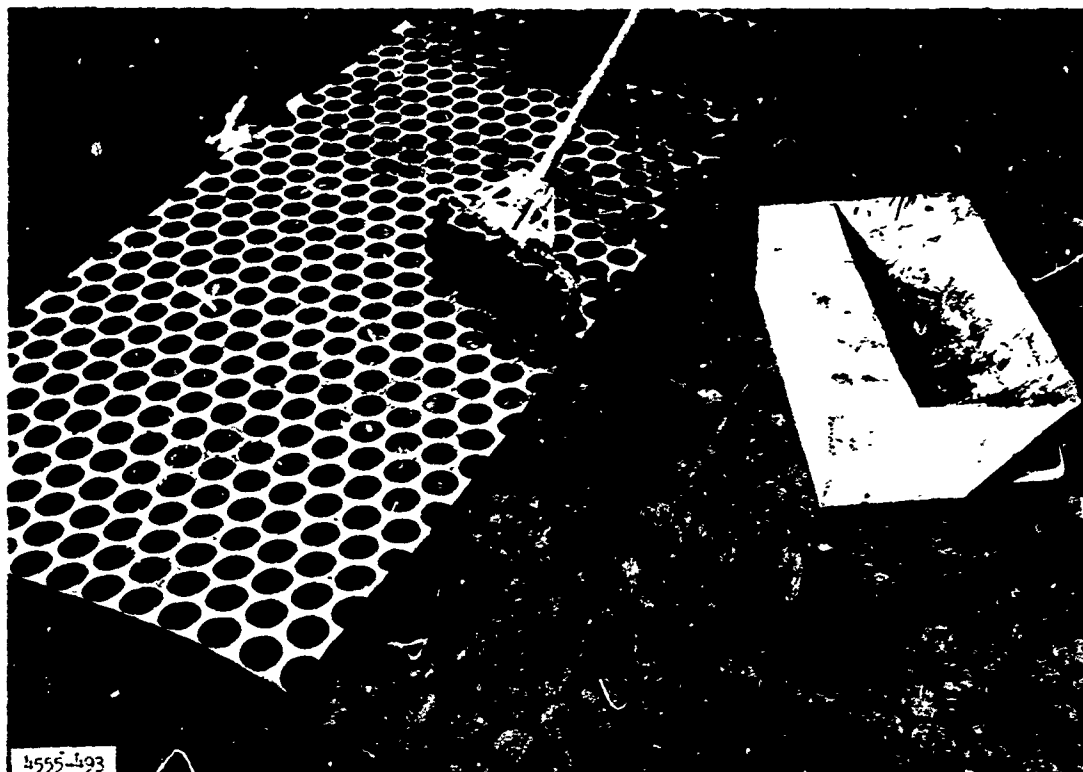
Photograph 95. Typical skid mark showing 50 percent retention of  
UNIROYAL 16246-1 nonskid compound after wet-skid test
